Your Inspection Report

123 Anywhere St.
Indianapolis, IN 46236

Keith Filipow - License No. HI00500119

Report No. 2812, v.2

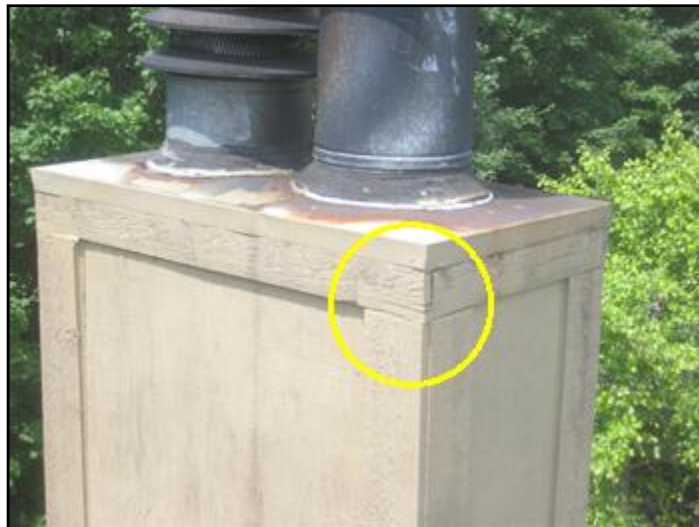
3.

2. Condition: • Rot

Rot was noted at the top trim of the chimney.

Location: Chimney chase

Task: Repair

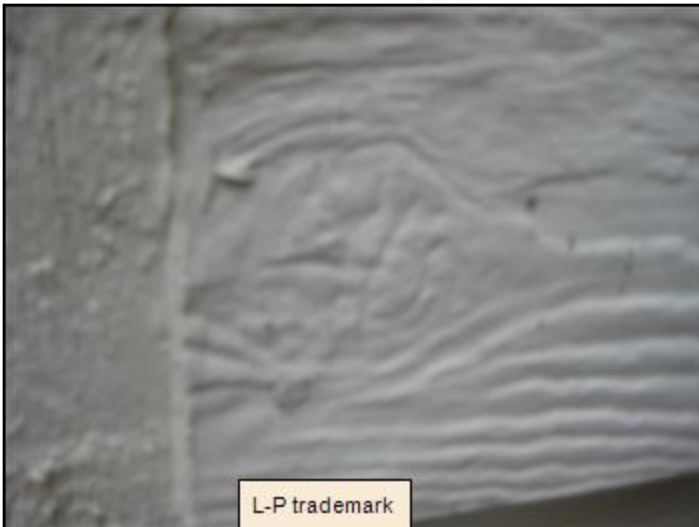
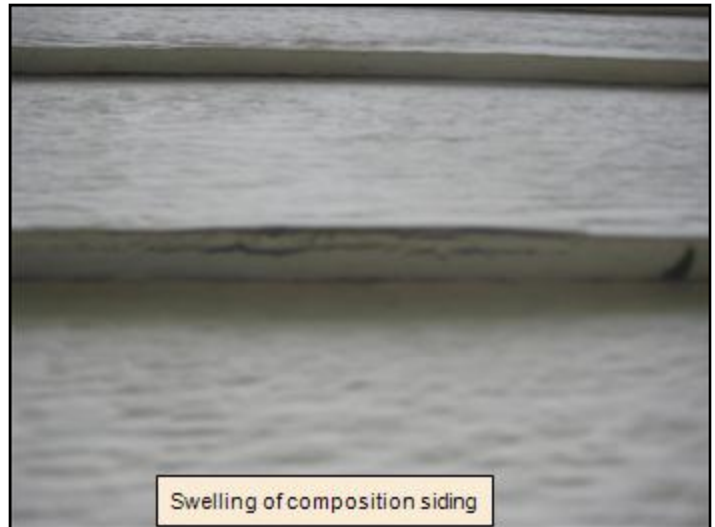
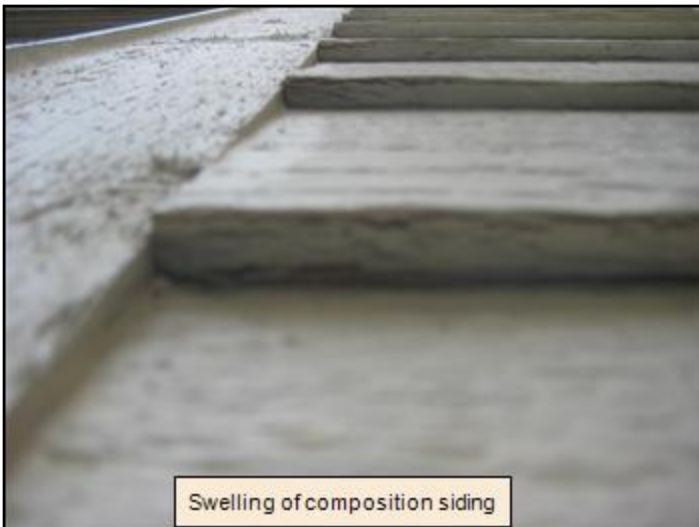
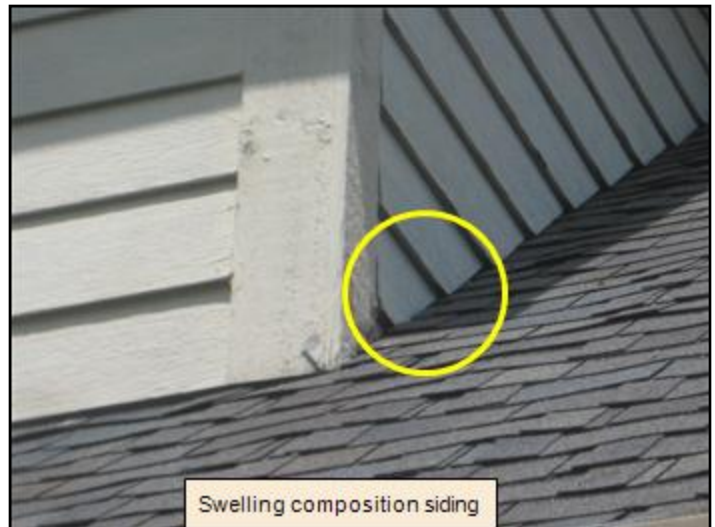
3. Condition: • [Swelling](#)

Wood composition siding, manufactured by Louisiana, is installed on the home. Swelling, a known defect, was noted in multiple areas. Good paint coverage will help prolong the useful life.

Location: Various

Task: Further evaluation by qualified contractor/personnel

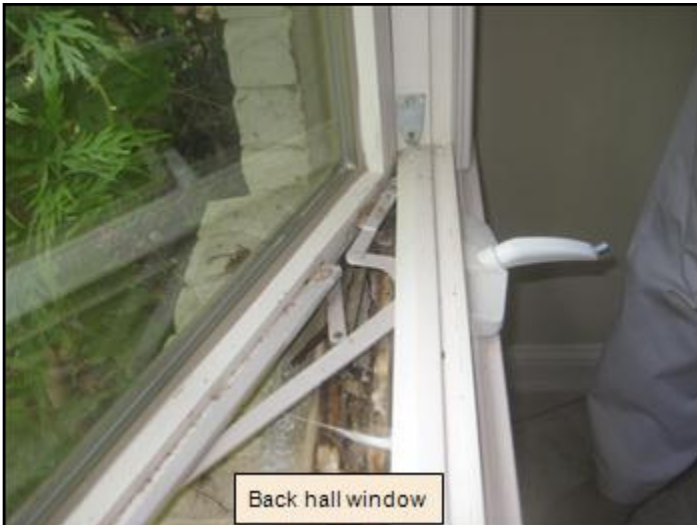
Back hall window

6. Condition: • Rot

Rot was noted at the following windows: west window southwest bedroom, dining room, northwest great room and transom above, northwest sunroom, lower front staircase, and back hall.

7. Condition: • Insect damage

Carpenter ants were noted at the window frame.

Task: Repair

Task: Treatment

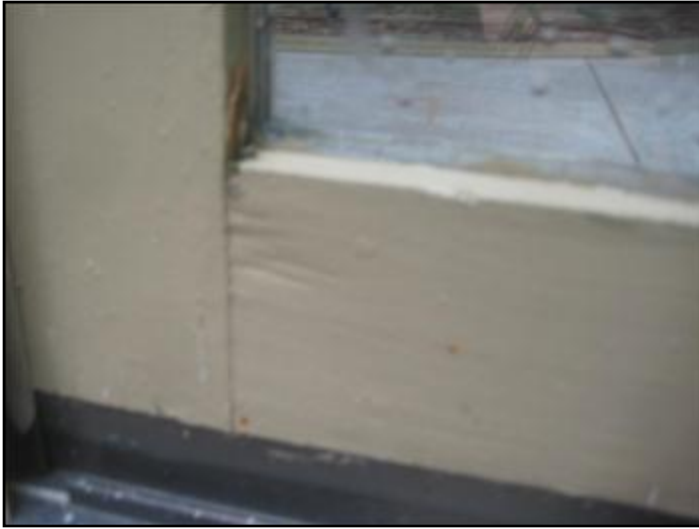
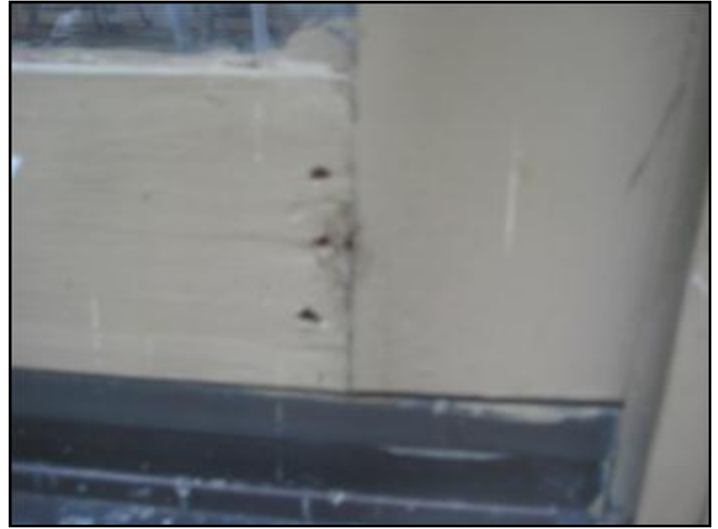
8. Condition: • [Rot](#)

Location: Kitchen Nook Slider

Task: Repair

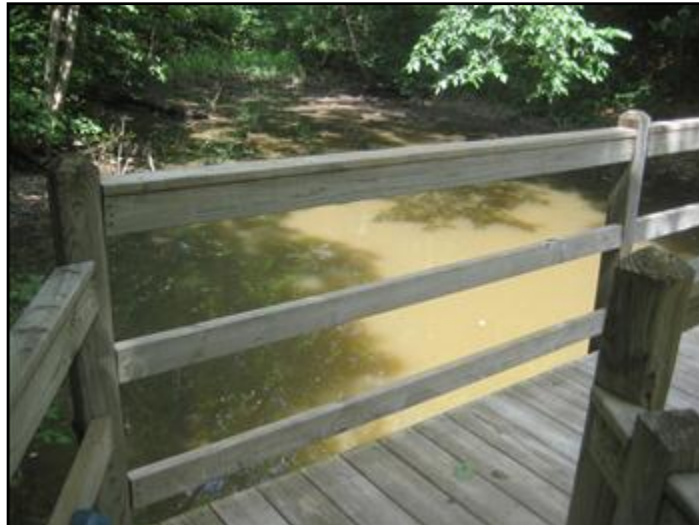
17.

9. Condition: • There is no graspable portion of handrail at the deck steps. This is improper.

Location: Deck

10. Condition: • [Spindles climbable](#)

Location: Walkway to Lake

Task: Provide

Task: Improve

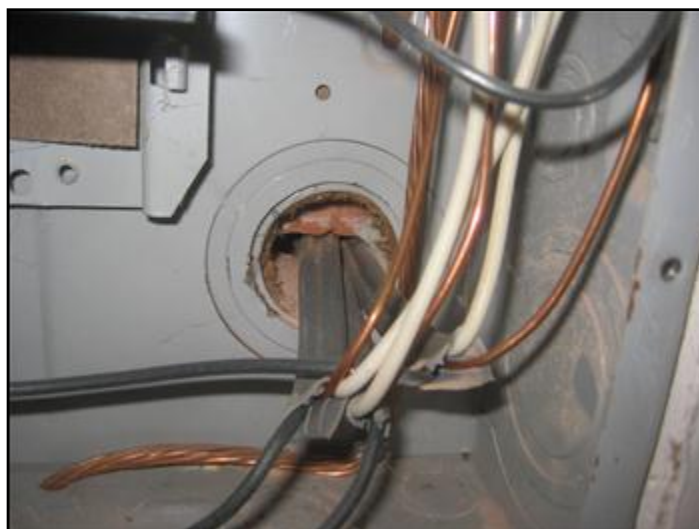
24.

12. **Condition:** • Wires enter the panel without use of connectors to secure them.

Location: Electrical Panel

Task: Improve

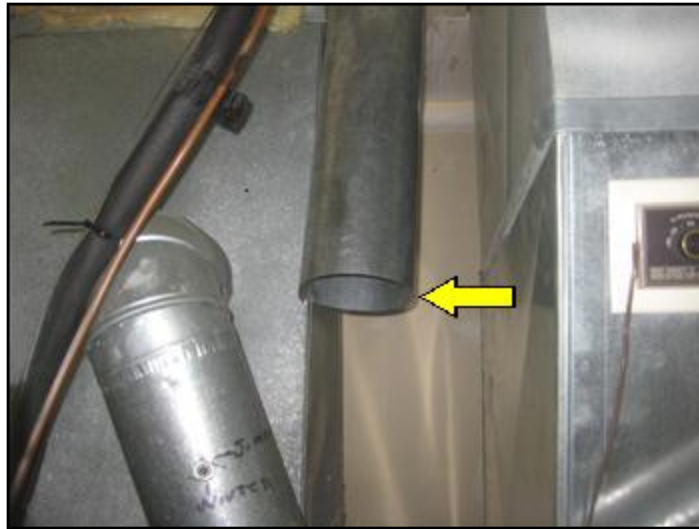
25.

17. Condition: • [Inadequate combustion air](#)

One six inch round combustion air inlet was noted in the closet. This does not meet the combustion air requirement for the furnace.

Task: Provide

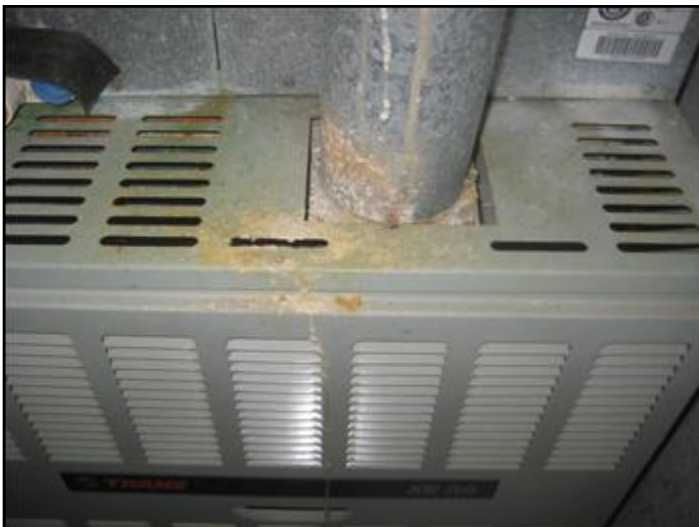
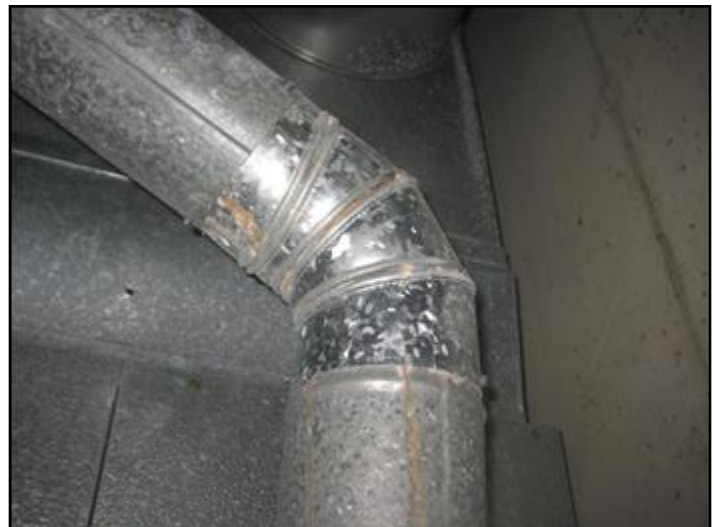
20. Condition: • Evidence of condensate leakage was noted at the flue pipe.

Location: Basement Furnace

Task: Further evaluation by qualified contractor/personnel

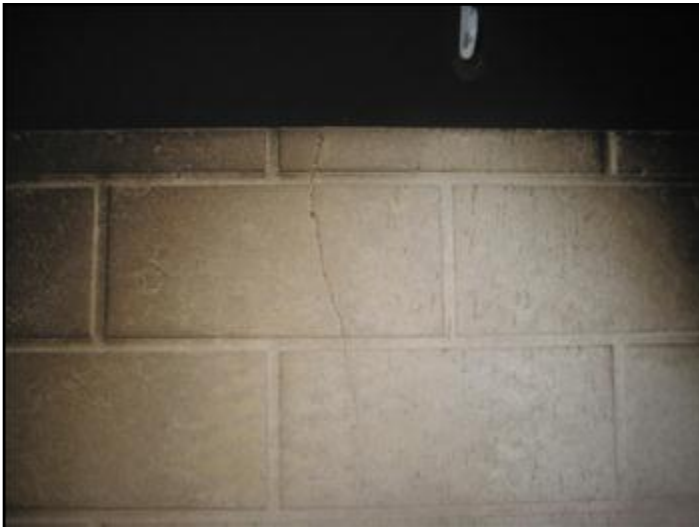
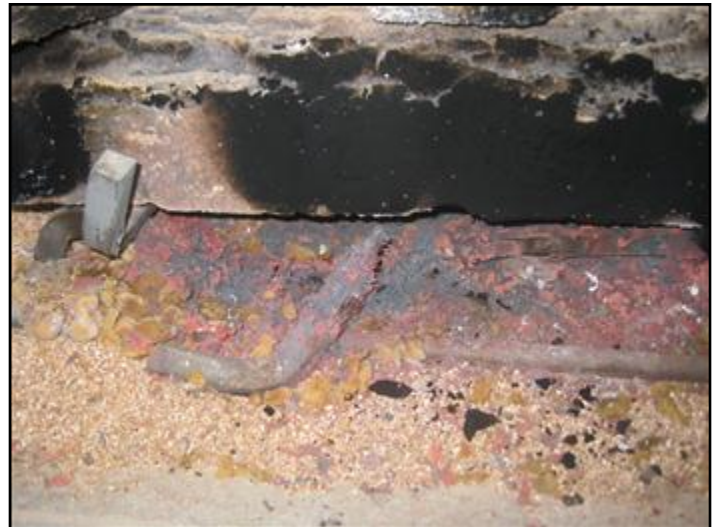
22. Condition: • A crack was noted at the rear panel and the hearth grate is deteriorated.

Location: Great Room Fireplace

Task: Monitor

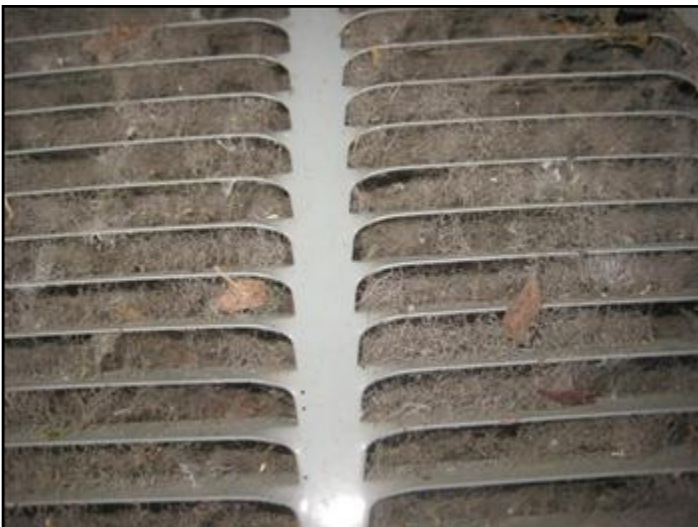
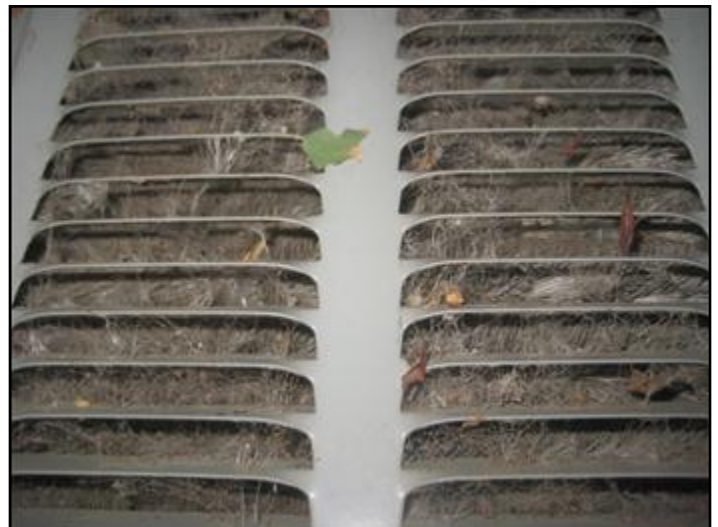
24. Condition: • [Dirty](#)

Location: Air Conditioner

Task: Clean

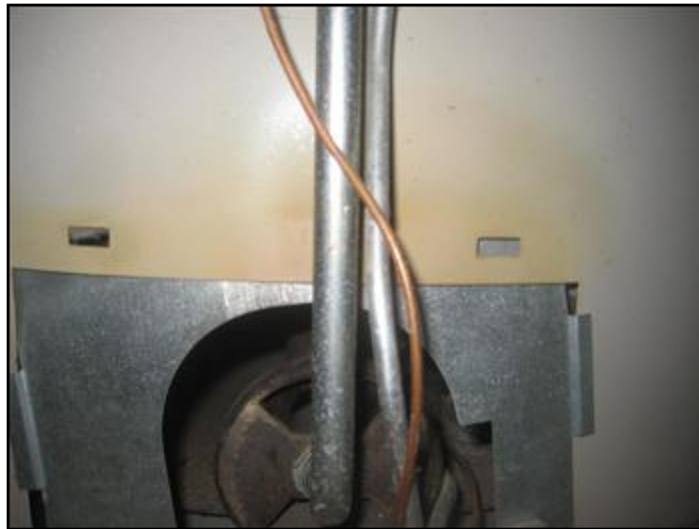
34.

28. Condition: • [Scorching](#)

Evidence of prior combustion spillage of combustion gas was noted at the burner access. This is likely due to lack of combustion air makeup in the room.

Location: Water Heater

Task: Monitor

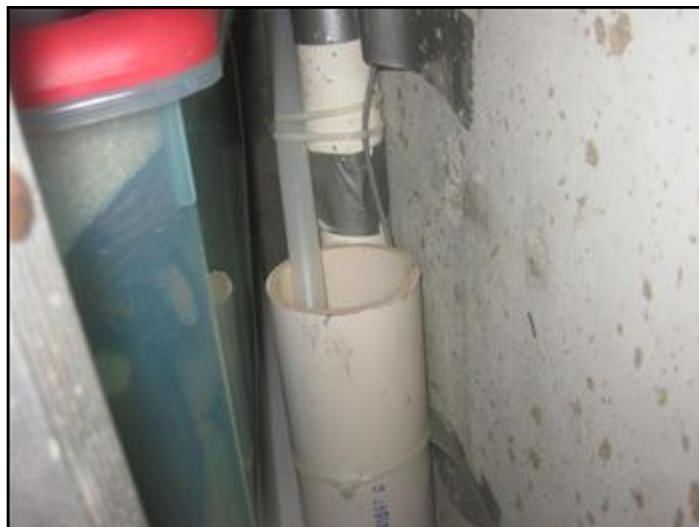
35.

29. Condition: • An unused and uncapped drain trap was noted at the ejector pit vent. A sewer gas odor was noted after operation of the ejector pump. The trap should be sealed until needed.

Location: Basement Furnace Room

Task: Correct

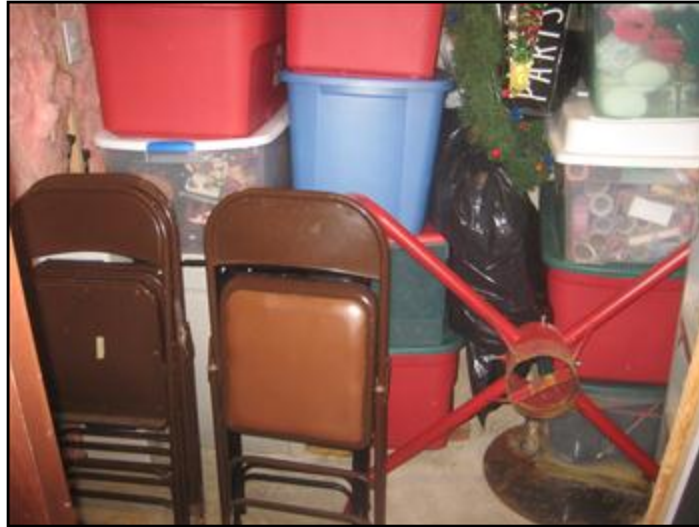
36.

30. Condition: • The pit and pump were inaccessible due to storage on top of pit.

Location: Sump pump

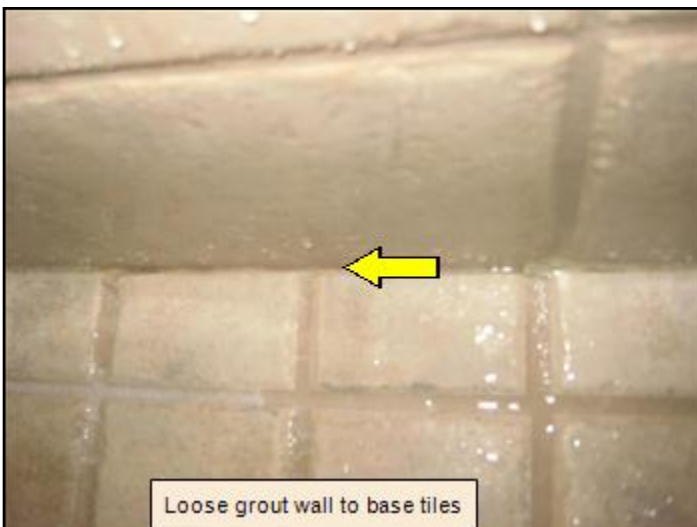
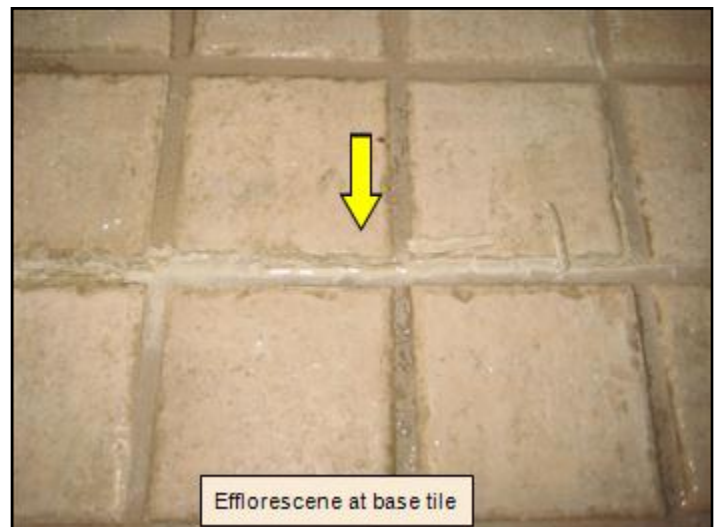
32. Condition: • Efflorescence was noted at the floor tiles. This is indicative of leakage under the tiles. Loose, cracked grout was noted at the base tiles, and cracks were noted at the corners of the wall to base tiles.

Location: Master Bathroom

Task: Further evaluation by qualified contractor/personnel

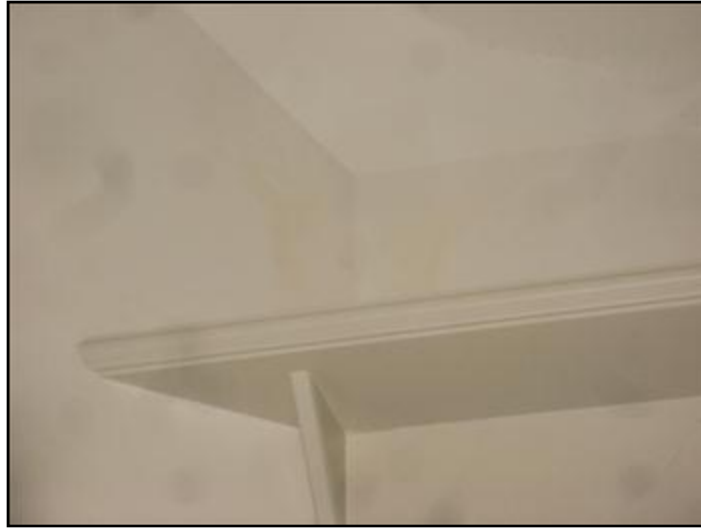
40.

34. Condition: • Stains and previous touch-up were noted at the wall above the sliding door. This tested dry at time of inspection.

Location: Southwest Sunroom

Task: Monitor

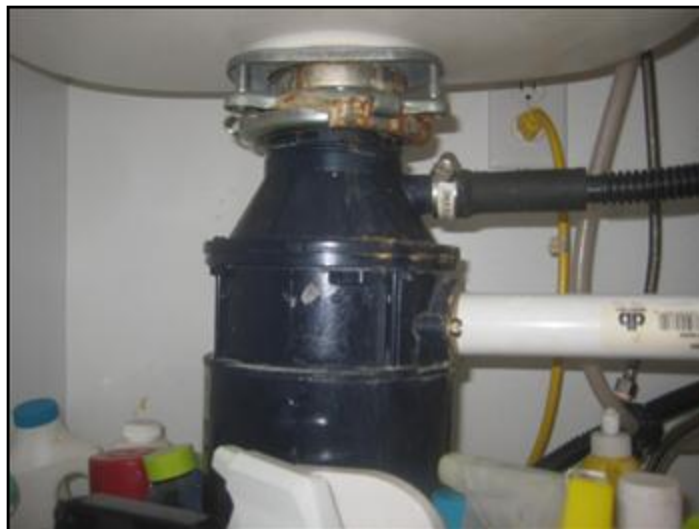
41.

38. Condition: • Near end of life expectancy

Rusting was noted at the housing.

Location: Disposal

Task: Monitor
